REPORT OF INVESTIGATION
(UNDERGROUND COAL MINE)

FATAL OUTBURST OF COAL ACCIDENT

No. 21 mine (ID No. 46-05801)
W-P Coal Company
Stirrat, Logan County, West Virginia

November 29, 1983

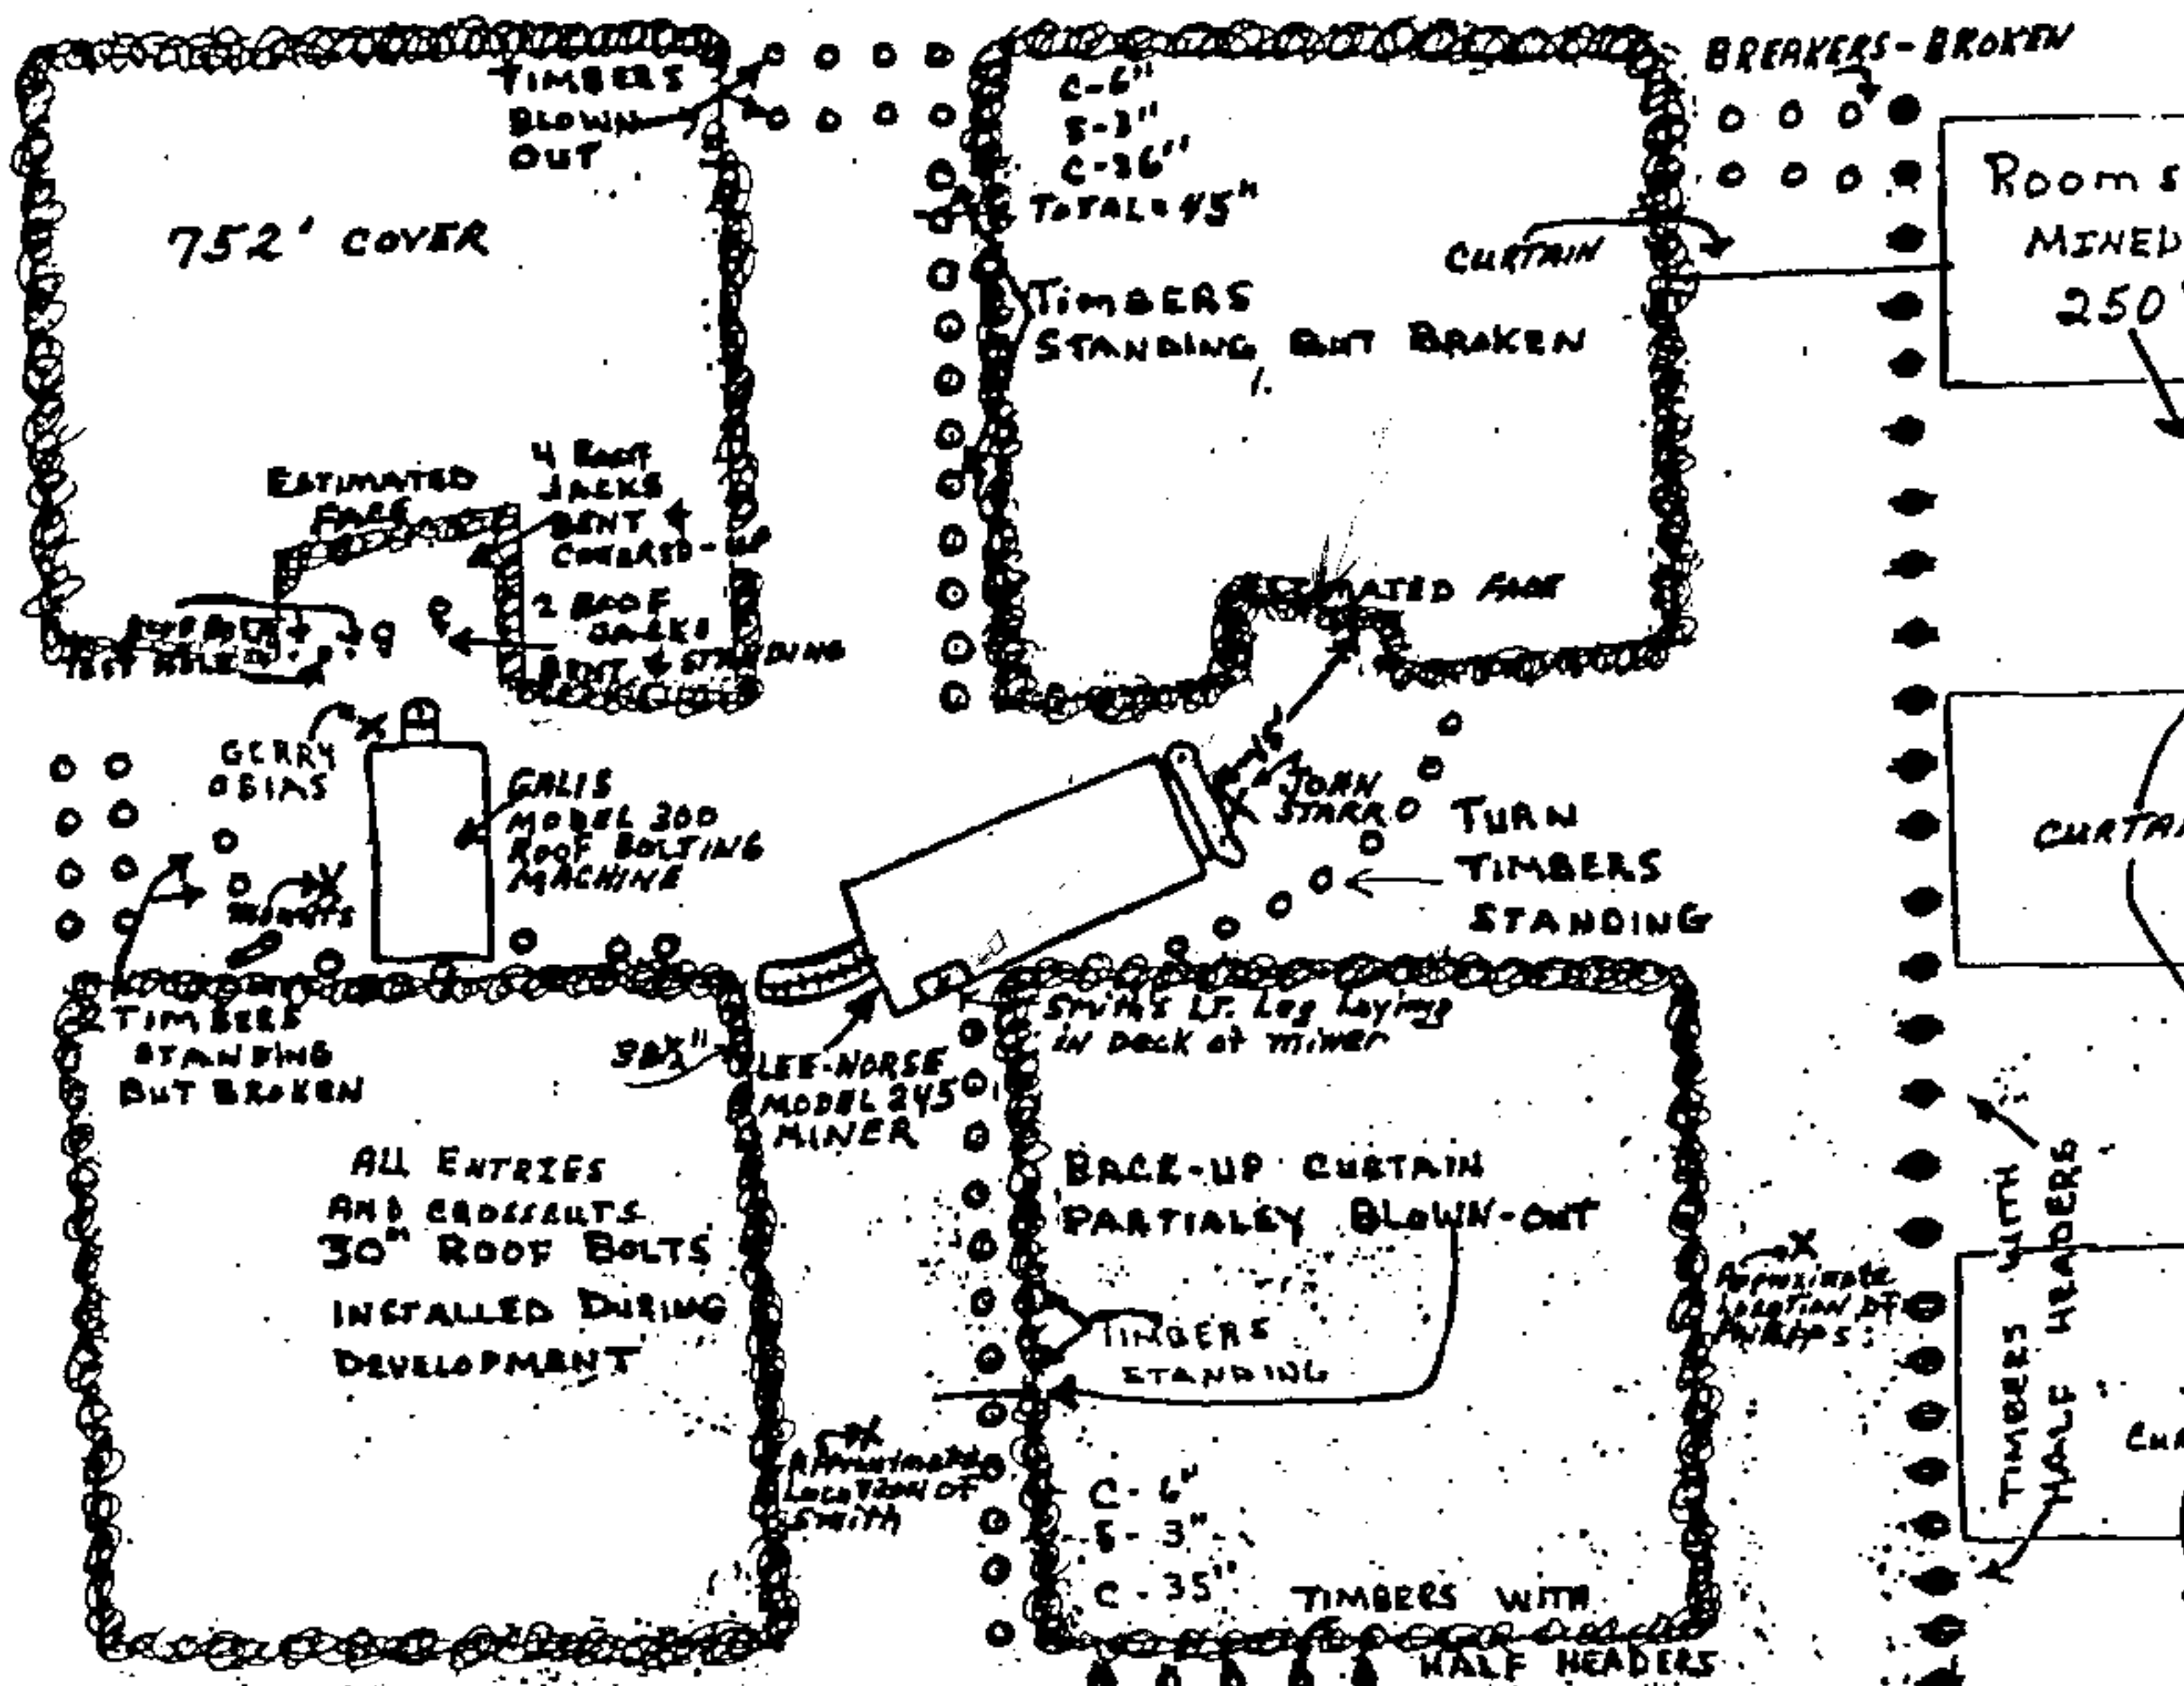
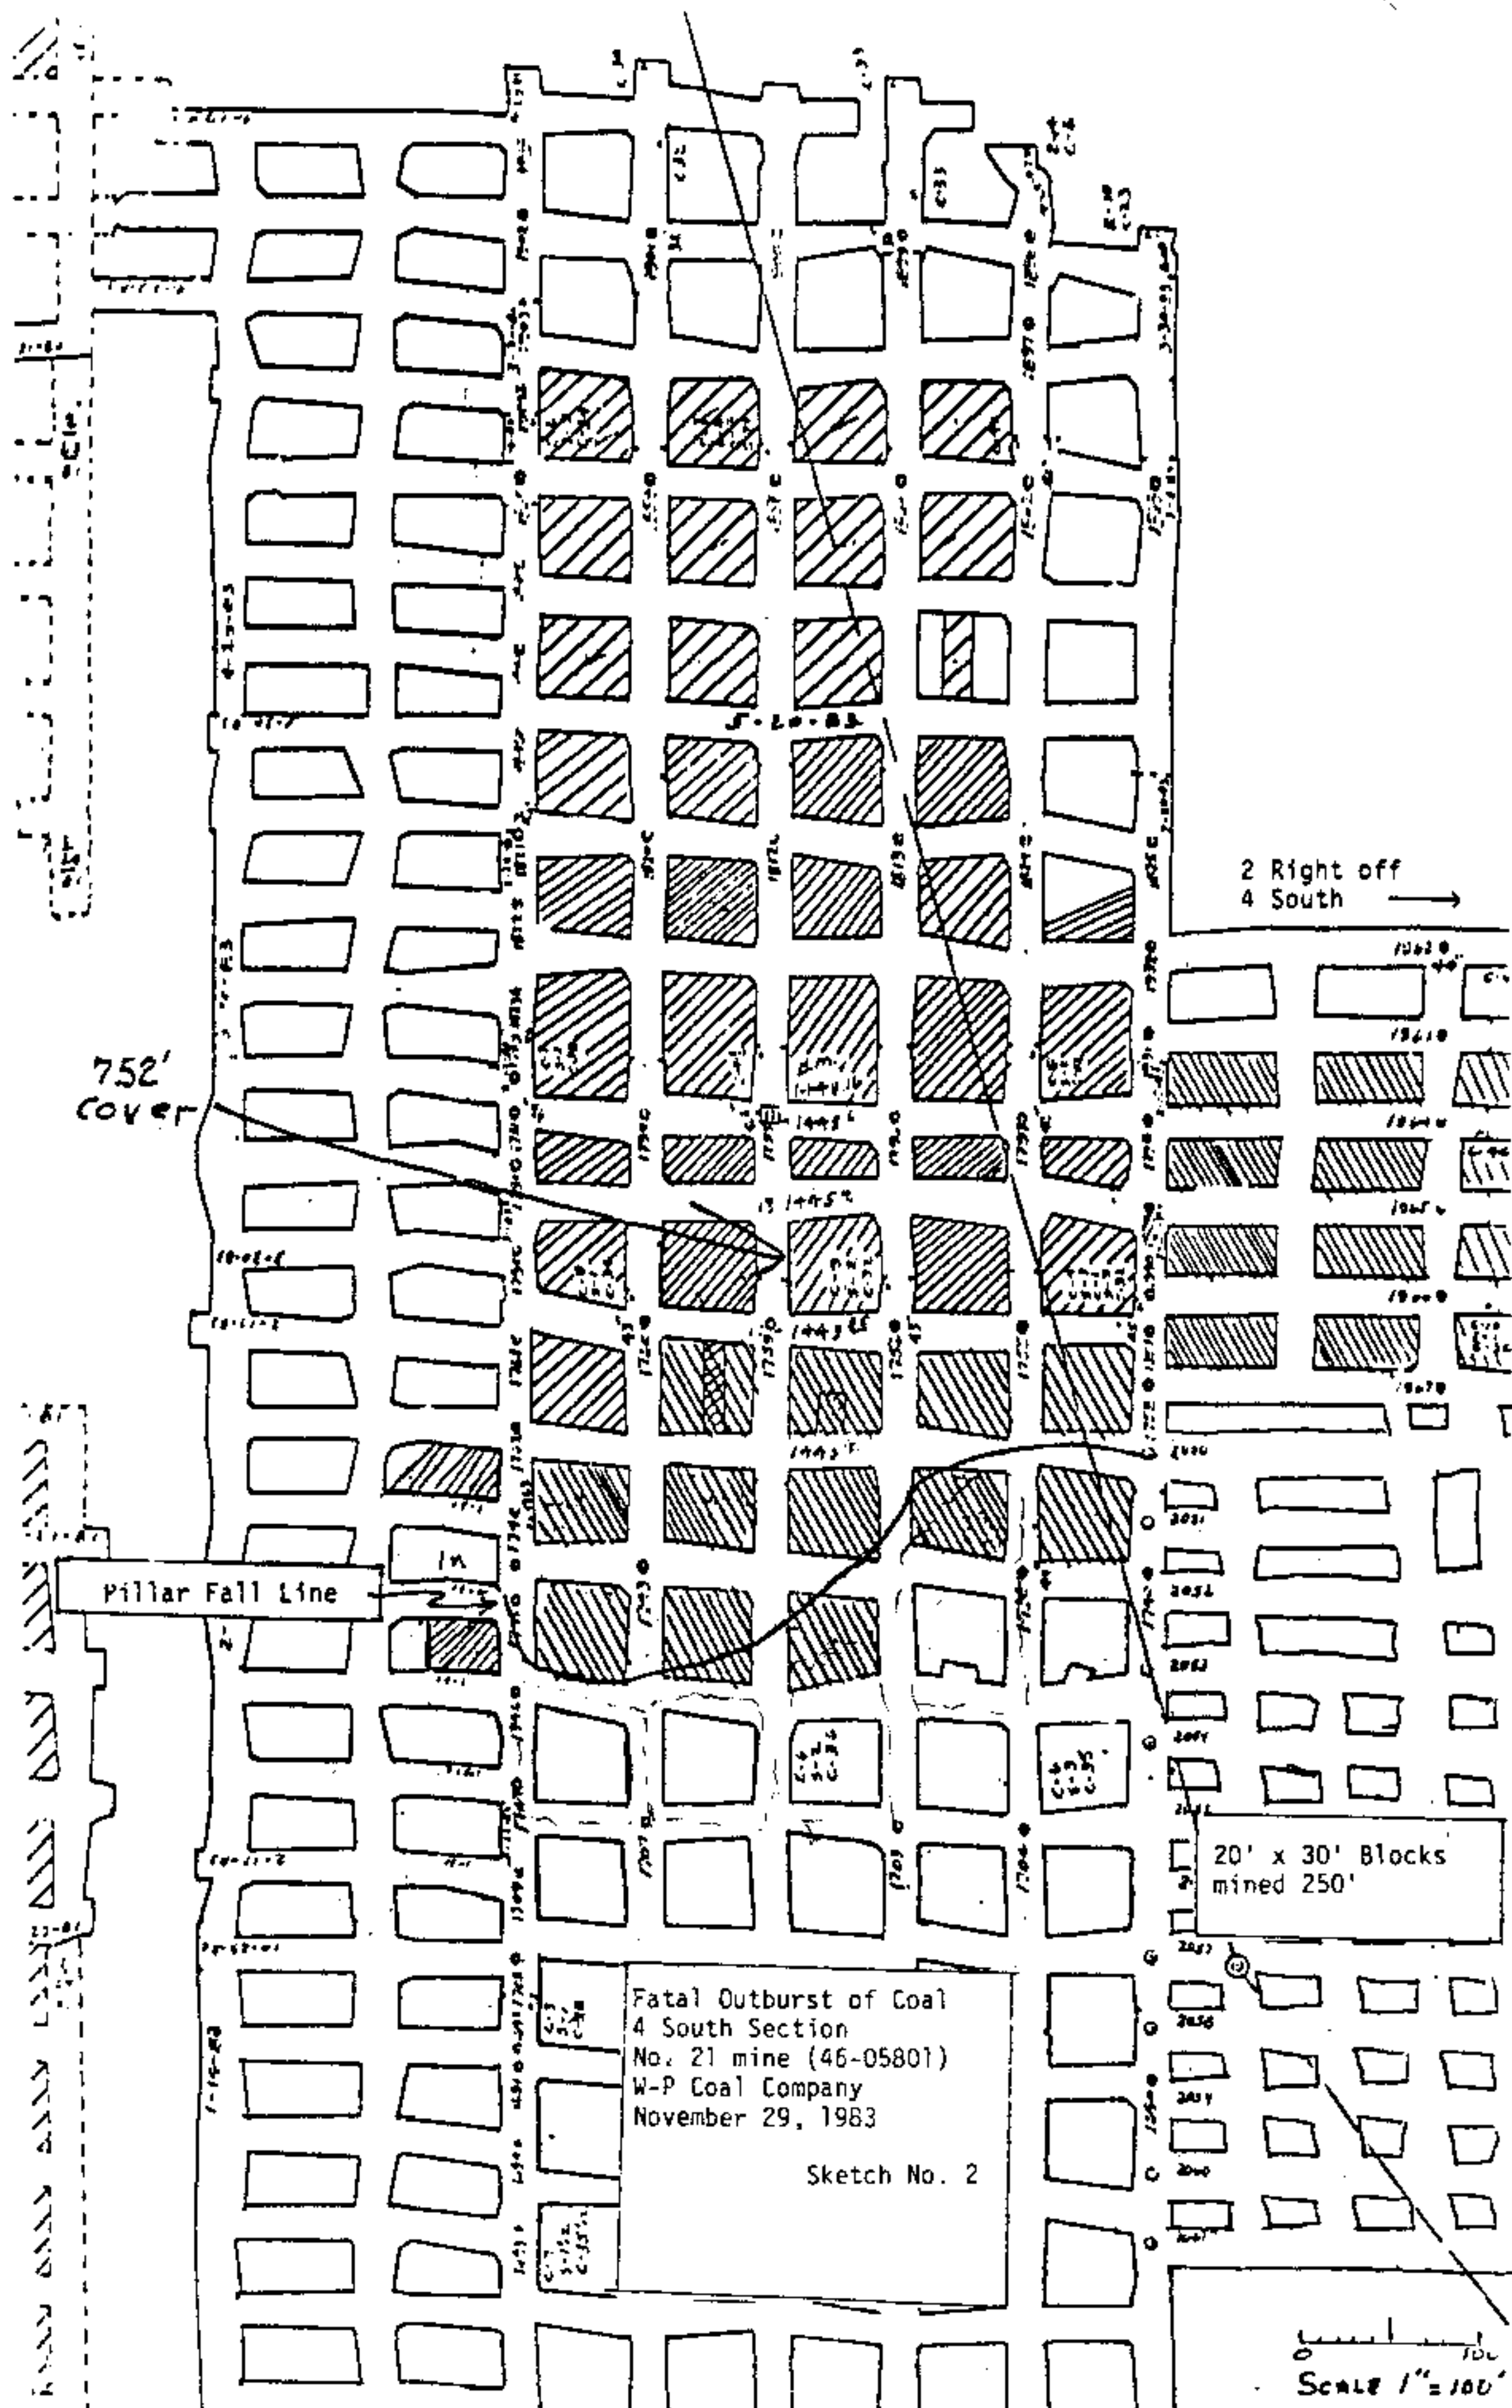
Sketch No. 1

On Tuesday, November 29, 1983, at approximately 5:15 p.m., an outburst of coal accident occurred in the Nos. 4 and 5 pillar workings, on the 4 south section (004-0), of No. 21 mine, W-P Coal Company, Stirrat, Logan County, WV. The accident resulted in five miners being injured. On December 2, 1983, Gerry Sias, roof bolting machine operator, died as a result of his injuries. Sias had 5½ years total mining experience, all at the No. 21 mine, and 3 years as a roof bolting machine operator. The accident and resultant fatality occurred when management failed to adopt a method of mining during overall pillar recovery that was designed to minimize the possibility of outbursts or squeezes.

5. Observations at the accident scene revealed that breaker and turn posts in the working faces and along the pillar line had been installed in excess of the minimum requirements of the approved roof control plan. The mined-out areas inby the pillar line revealed that a partial roof fall (1-2 feet thick) had occurred to the left of the accident scene. The roof inby the Nos. 4 and 5 pillar blocks being mined was still standing for a distance of about 70 feet. (See sketch No. 1.) When the outburst occurred, coal was dislodged from the ribs of the pillars for one crosscut and deposited on the mine floor. The depth ranging from 0-38 inches.

7. An examination of the No. 4 pillar working face revealed the forces on the coal block were exerted from the area inby and to the right of the pillar. The two temporary roof support jacks still standing were bent in the outby direction and toward the No. 4 entry. The face of No. 5 pillar block contained a small opening which allowed slight visibility over the top of the coal pillar. The coal pillars in the rooms off No. 6 entry revealed that the roof was still standing but large amounts of coal had been dislodged from the pillar ribs for as far as one could see (about 60 feet into the rooms) along the present pillar line and inby for about 60 feet. Coal sloughing from the ribs was present in the rooms outby the present pillar line for one crosscut.
